KIC TECHNICAL BULLETIN

TIPS FOR AVOIDING DRUM FAILURE

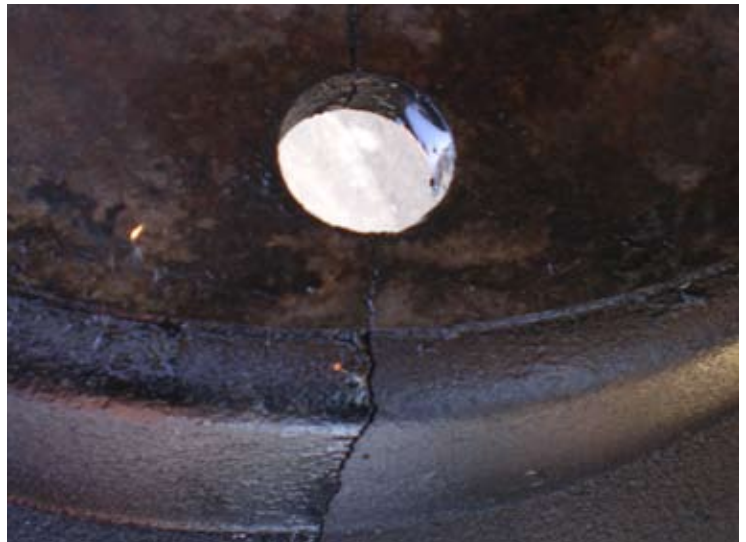
The most prevalent premature failure of a brake drum is illustrated in the top photo. A crack has propagated across the center of a wheel stud hole and extends down the side of the drum. This is caused when a drum is not properly seated on the hub and is misaligned or cocked during assembly.

During installation the heavy drum can hang up on the small step between the wheel and drum pilot diameters on the hub. Therefore the portion of the drum at the 12:00 position does not rest on the flange of the hub, instead there is a gap between these mating surfaces. When the wheel and wheel nuts are installed and torqued it creates a high concentration load on the portion of the drum flange that is not supported by the hub. If a stud hole is in this location there is less cross sectional area to resist the load. The relatively brittle cast iron drum can crack.

To avoid misalignment between the drum and the hub, the wheel nuts should be installed and snugged to about 50 ft- lbs in the sequence shown in Figure 1. The crisscross sequencing allows the drum to properly seat itself if it wasn't fully seated prior to installing the wheels. It can "ratchet" into its fully seated position. After all of the nuts are installed, tighten the nuts to the recommended torque shown in Table 1 below using the same crisscross sequence. If the wheel nuts are fully torqued without the 50 ft-lb step, the drum can cock and remain misaligned during the remaining nut torquing.

Another cause for misalignment is improper cleaning of the hub before installing a new drum. During normal operation the drum pilot diameter on the hub gets rusty and encrusted with road debris. If the pilot diameter is not cleaned, the material build-up can make it difficult to slide the heavy drum into position. The drum may appear to be in full contact with the hub flange, when in fact it is seated against a heavy build up of road debris. This is especially true in areas where urea and other de-icing chemicals are used in the winter. These chemicals can form rock hard material build up which may require a chisel to remove. Clean the pilot diameter with a wire brush before mounting.
